Manhole Inspection Summary

Manhole # **S19G__041MH**

Insp Date: **10/8/07 12:27 PM**

Location Address: **102 VINE ST**

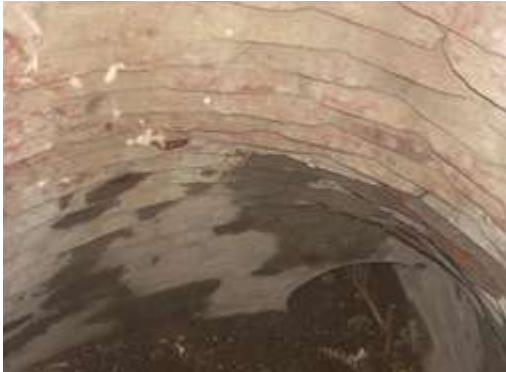
Defect 3

Infiltration: ☐ None ☐ Joint ☐ Cracks ☐ Mortar ☐ Roots ☒ **Wall**

INFILTRATION OF THE BARREL WALL

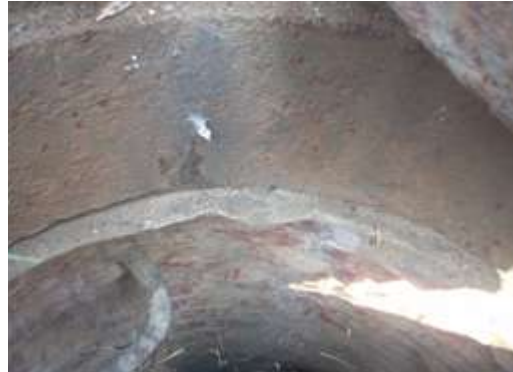
Defect 2

Frame Offset: **0.5** (in.) Condition: ☒ Sound ☐ Cracked ☐ Leaks

FRAME OFFSET

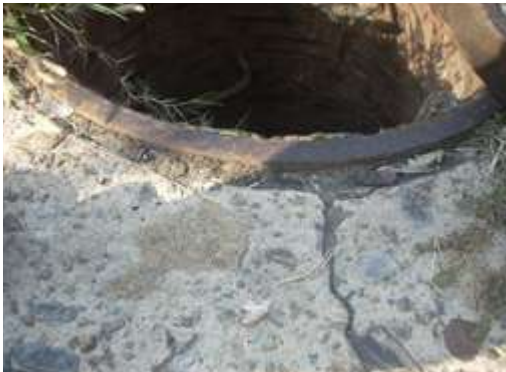
Defect 1

Cover Shape: **Circular** Diameter: **24** (in.) Length: (in.) Dist A/B Grade: **0.5** (in.)

GRADE ADJUSTMENT

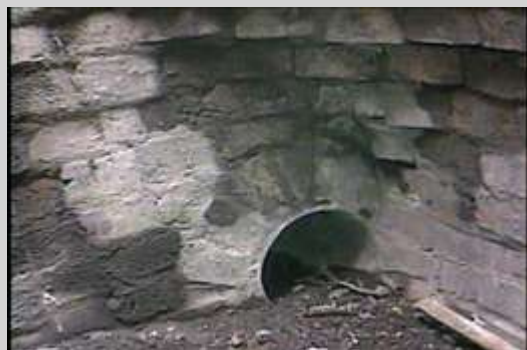
12 O'Clock Outflow

8 in. Circular Gravity Sewer
Pipe Out @ 12 O'Clock

Deposits: ☐ None ☒ **Mud** ☐ Sludge ☐ Debris ☐ Grease

Silt Depth: **1** (in.) Deposits Extent: **Light**
